USS Princeton (CG 59): Impact of Marine Macrofouling (Mussels and Hydroids) on Failures/Corrosion Problems in Seawater Piping Systems

Dr. Joanne M. Jones and Dr. Brenda J. Little

The First Annual Navy Corrosion Control Workshop

USS PRINCETON (CG 59): IMPACT OF MARINE MACROFOULING (MUSSELS AND HYDROIDS) ON
FAILURES/CORROSION PROBLEMS IN SEAWATER PIPING SYSTEMS

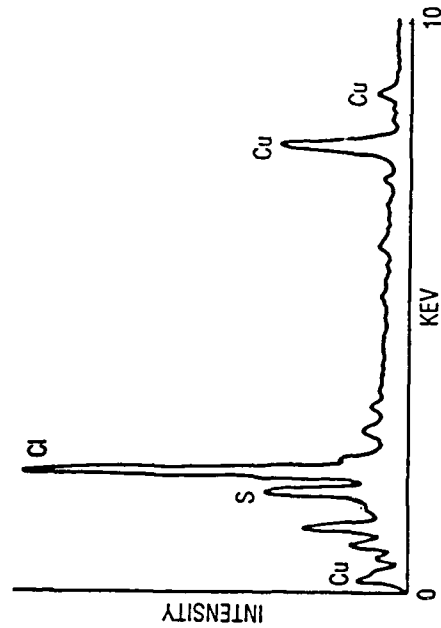
The hydroids had collected large amounts of chlorine, sulfur and copper as demonstrated by EDAX (energy dispersive X-ray) analysis.

EDAX SPECTRUM OF THE HYDROIDS REMOVED FROM CG 59 SEAWATER PIPING SYSTEMS SHOWED LARGE AMOUNTS OF CHLORINE, COPPER AND SULFUR
